Manhole Inspection Summary

Manhole # **S11GG_036MH**

Insp Date: **1/13/09 11:46 AM**

Location Address: **3017 PRESBURY ST**

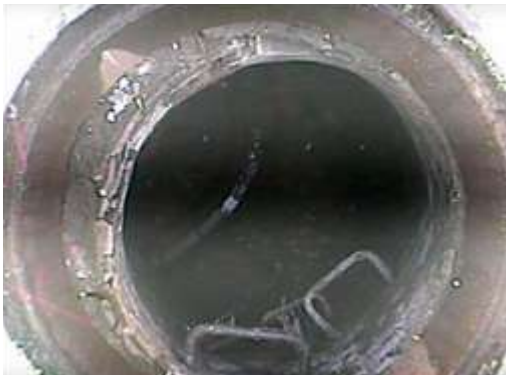
Defect 1

Frame Offset: **2** (in.) Condition: ☒ Sound ☐ Cracked ☐ Leaks

Steps Count: **3** Missing: **0** ☒ **Corroded**

CORRODED STEPS AND FRAME
OFFSET

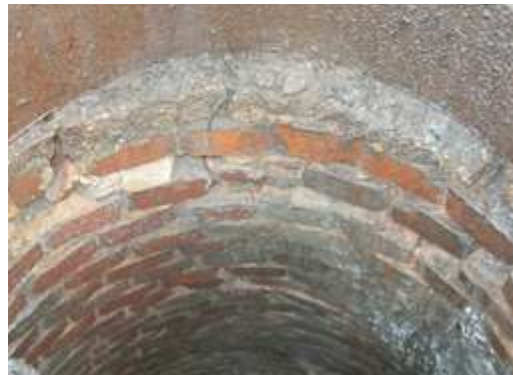
Defect 2

Condition: ☐ Sound ☐ Cracked ☐ Root Intrusion ☐ Loose Brick ☒ **Deteriorated**

deteriorated chimney

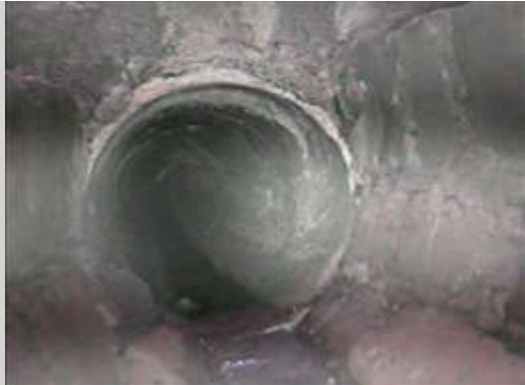
12 O'Clock Outflow

8 in. Circular Gravity Sewer
Pipe Out @ 12 O'Clock

Infiltration: **None** Pipe Seal Cond: **Sound**

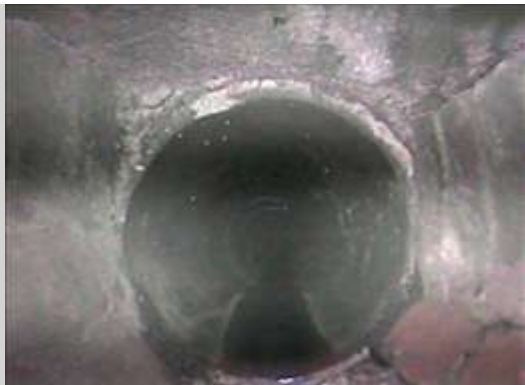
8 O'Clock Inflow

8 in. Circular Gravity Sewer
Pipe In @ 8 O'Clock

Infiltration: **None** Pipe Seal Cond: **Sound**
